Shanghai BOCI Automation Technology Co., Ltd.

# BLT Lower Protective Lens Temperature Rise Alarm FAQ

**Version: V1.0**

Release date: 2022.3.30

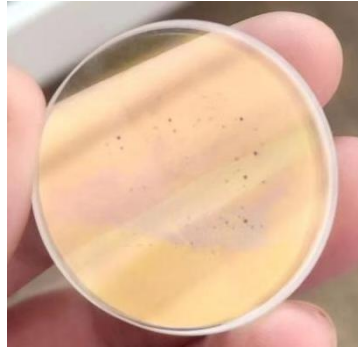
#### 1.1.1 Burning point on the lower surface of the lower protective lens

- **Cause: The perforation focus point is too negative, causing the perforation slag to return to the lens.**
  - Solution: Elevate the perforation focus point.

- **Causes: Inappropriate perforation energy, perforation time is too extreme, perforation burst hole.**
  - Solution: Reduce the duty cycle and increase the piercing time.

- **Cause: Parts common edge layout cutting, plate deformation joint cut can not be connected.**
  - Solution: Common edge jointing tool position with perforation, or typesetting parts to increase the micro-links.

- **Cause: Metal particle contamination in the air pipe.**
  - Solution: Clean the pipes or replace them, find the source of metal dust source and replace it (pipe joint connections, etc.).

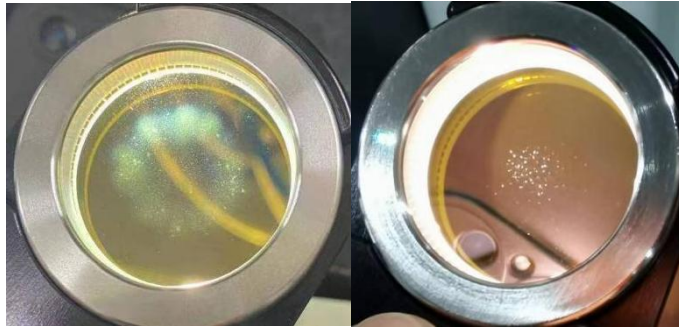
### 1.1.2 Lower protective lens surface with dust, oil or white spots

- **Cause: The air compressor filtration does not meet the use standard.**
  - Solution: Check the air compressor filter cartridge for failure or increase the filtration level.

- **Cause: The air pipe is not clean.**
  - Program: unplug the air inlet pipe of the cutting head, flush with high purity alcohol from the air inlet filled with atmospheric pressure, repeatedly clean the pipe 3-4 times, or replace the air line pipe.

- **Cause: The air inlet seat screen is blocked by PTFE tape or other foreign objects.**
  - Program: disassemble the air inlet seat and check whether the air inlet filter screen is blocked by foreign objects.

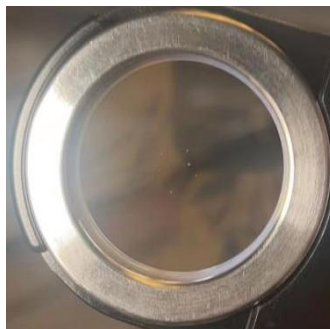
### 1.1.3 White spots on the upper surface of the lower protective lens

- **Cause: Improper handling during lens replacement, resulting in dust falling onto the lens.**
  - Program: before replacing the protective lens, please close the surrounding fan, seal the nozzle with tapes, clean the dust under the protective lens door cover position, the above steps operation is completed before inserting and removing the drawer to replace the lens, the drawer must be

pulled out in time to close the door cover, drawer inserting and removing action should be gentle.

- **Cause: Lower protective lens was struck through, contamination exists between the lower protective and lower second protective lens.**
  - Solution: Clean the passage between the lower protection and the lower second protection with a long cotton swab and alcohol wipe.

- **Cause: Failure of the spring seal of the lower protective lens drawer.**
  - Solution: Replace with a new spring seal.
